# A sustainable solution for massive coastal erosion in Central Java

~ Towards Regional Scale Application of Hybrid Engineering ~  
Discussion paper

February 2014

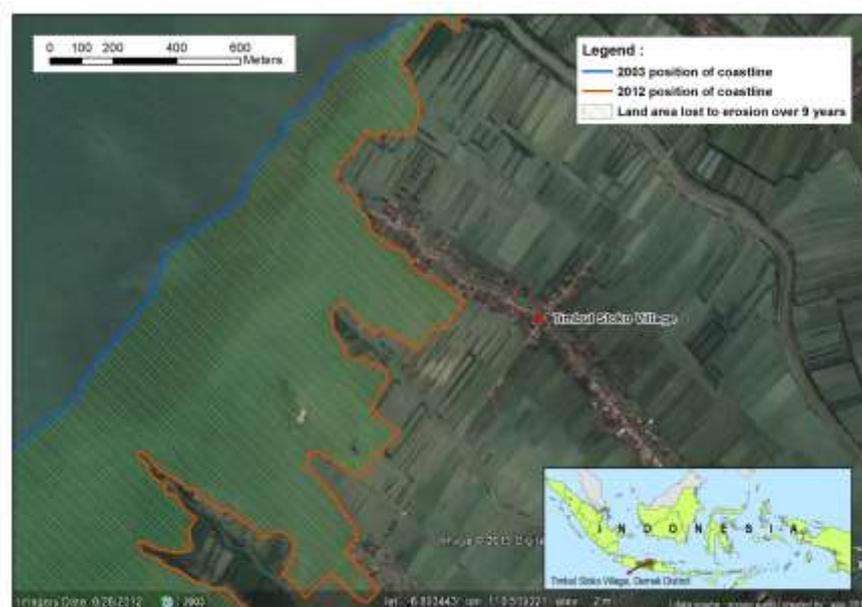
Figure 1. Example of coastal erosion in Demak, Java.

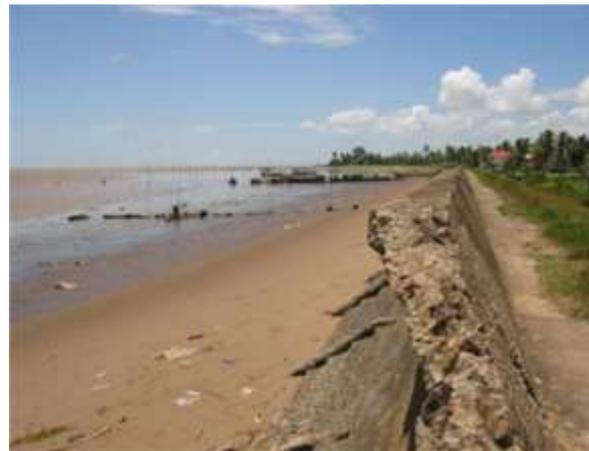
Figure 2. a collapsed structure in British Guyana  
(photo by H. Winterwerp)

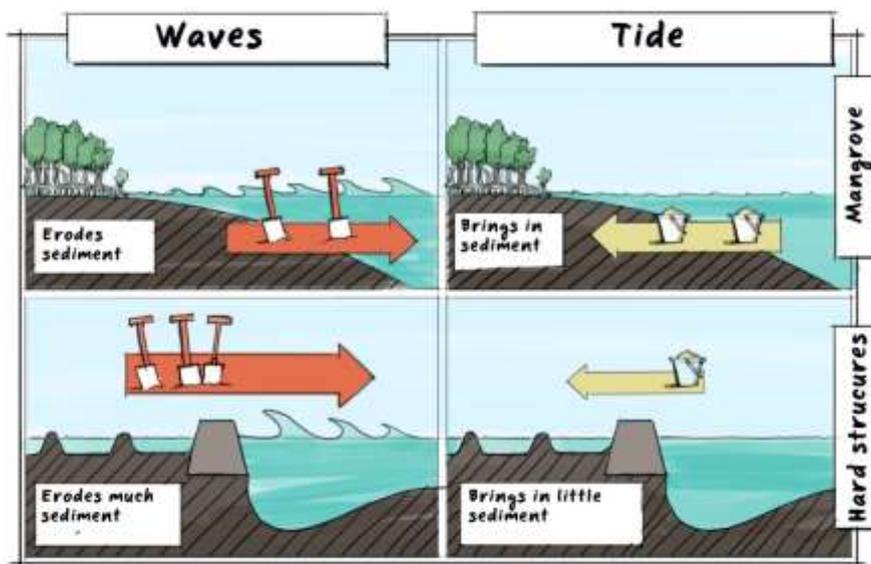
When mud-coasts start to erode as a result of unsustainable land use, the delicate balance between erosion and sedimentation is disturbed. Sediment is lost to the sea through rivers that are disconnected from the surrounding floodplain and through waves by loss of the protective function of mangroves. As result the coastline progressively recedes. Coastal managers often try to fight coastal erosion with classical solutions, such as dikes and seawalls, e.g. with hard structures. In a healthy mangrove ecosystem, waves take sediment away and the tides and rivers bring sediment to the coast. The mangroves' root system helps to capture and stabilize the sediment. The tidal flat is convex up, with a gentle slope and shallow water at the seaward edge of the mangrove forest. Hard structures, such as aquaculture pond bunds and breakwaters, disturb the balance of incoming and outgoing sediment. Waves reflect on the structure, becoming bigger and taking even more sediment away. The tide cannot bring enough sediment in, as it is blocked by the hard structure. The tidal flat becomes concave-up, with steep slopes, and deep water at the seaward edge of the mangrove forest. As a result, waves can penetrate further, enhancing their erosive forces. These processes are illustrated in the cartoon above.

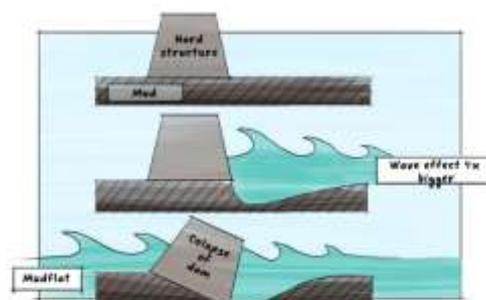
Hard structures therefore only exacerbate the problem (illustration on the right). Waves get bigger when they reflect on a hard structure. These bigger waves can erode 2 to 4 times more soil in front of the hard structure, eventually leading to the collapse of the structure. Such collapsed sea walls are useless in preventing erosion, but still increase the height of the waves.<sup>13</sup>

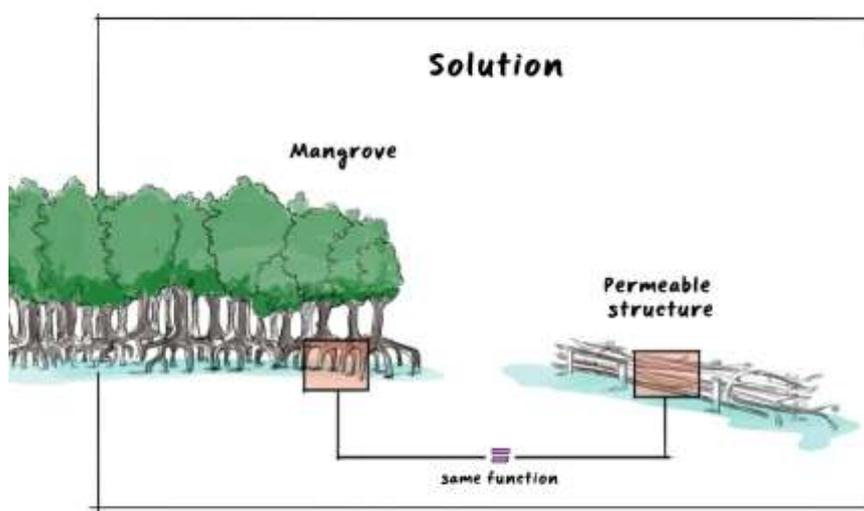
In order to stop the erosion process and regain a stable coastline, the first necessary step is to restore the sediment balance. More sediment needs to be deposited on the coast than the amount being washed away. A favourable way to do this is by working with nature, using smart engineering techniques – giving nature a little help, but letting nature do the hard work. While increasing sediment input from the river, sediment output by waves from the sea should be limited. Permeable structures made of local materials such as bamboo, twigs or other brushwood can be placed in front of the coastline to reduce sediment loss. These structures let the sea and river water pass through, dissipating the waves rather than reflecting them. As a result, waves lose height and energy before they reach the coastline. The permeable structures also let mud from the seaside pass through, while creating calm water conditions allowing settling of fine sediments. This way the structures will increase the amount of sediment trapped at or near the coast. These devices imitate nature – mimicking the structure of a natural mangrove root system (see illustration below).

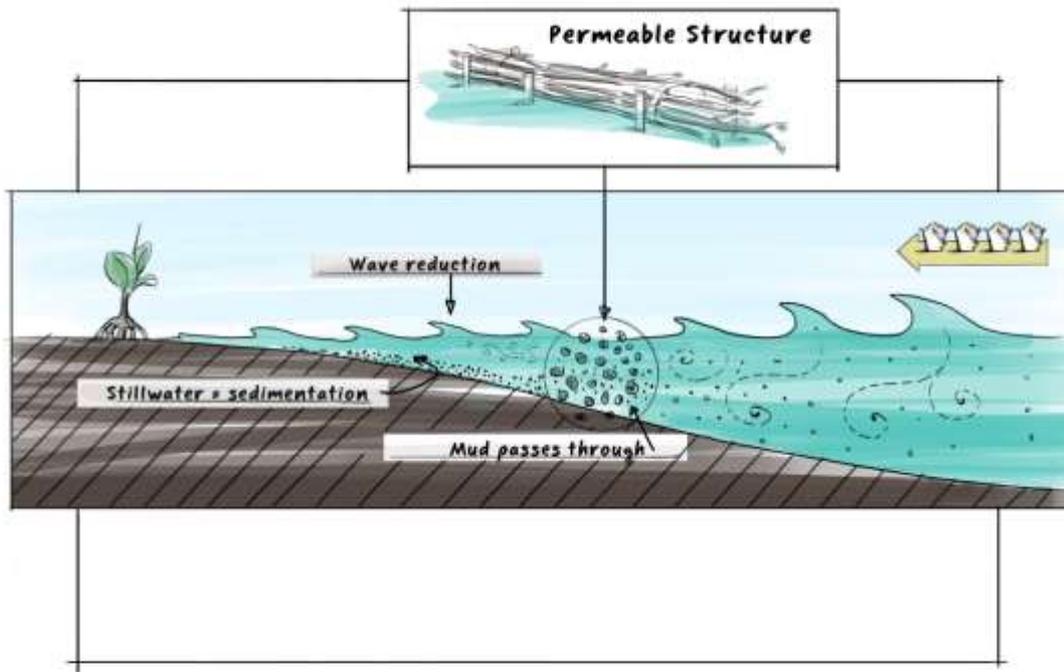
The Hybrid Engineering approach combines these permeable structures (to break the waves and capture more sediment) with engineering techniques, such as agitation dredging, which increase the amount of sediment suspended in the water. Once the erosion process has stopped and the shoreline has accreted to sufficient elevation, mangroves are expected to colonize naturally. The new mangrove belt can further break the waves and capture sediment in the long term. The Hybrid Engineering technique described above is applied in grids, or in longer lines of permeable structures to steadily reclaim land from the sea. This technique has been applied successfully in salt marshes in the Netherlands and Germany for centuries. Hybrid Engineering is being increasingly applied in vulnerable coastal areas across the world, replacing hard structures in a cost-effective manner. However, the technique only works if properly applied. Regular maintenance of the permeable structures is needed. New structures need to be placed at the seaward end once sufficient sediment has been trapped on the coast when the desired amount of land is reclaimed. This 'recovery cycle' is shown in the illustration at the cover page.

The Hybrid Engineering approach in tropical mud coasts contains a number of elements, which can be applied jointly or separately (see illustration above):

1. Installation of permeable structures with brush-wood. Such structures have been applied successfully during centuries in temperate coastal wetlands (Netherland, Germany, England) to reclaim fertile land from the sea. Recently, such constructions have also been tested in Vietnam<sup>14</sup>.

2. Seabed agitation (symbolised by the arrow with buckets in the illustration above) to enhance fine sediment concentrations in the foreshore. The classical agitation technique is known as agitation dredging through which fine sediments are taken from the seabed, pumped into a barge, and from there the fines may flow freely again in the water column. In the very shallow waters of a mangrove-mud coast, other ways of mechanically stirring the seabed have to be deployed.

3. Mud nourishments (also symbolised by the arrow with buckets in the illustration above), i.e. the placement of mud directly in the area where it is needed, may be used at locations where the tide has difficulties to bring fine sediments to the shore, or where too much sediment already has been washed away. Though beach nourishments with sandy sediments are being carried out throughout the world, nourishments with mud have to be designed carefully.

4. Construction and/or restoration of the so-called cheniers, thin and narrow lenses of sand on top of the muddy bed, at which waves may break, losing part of their energy.

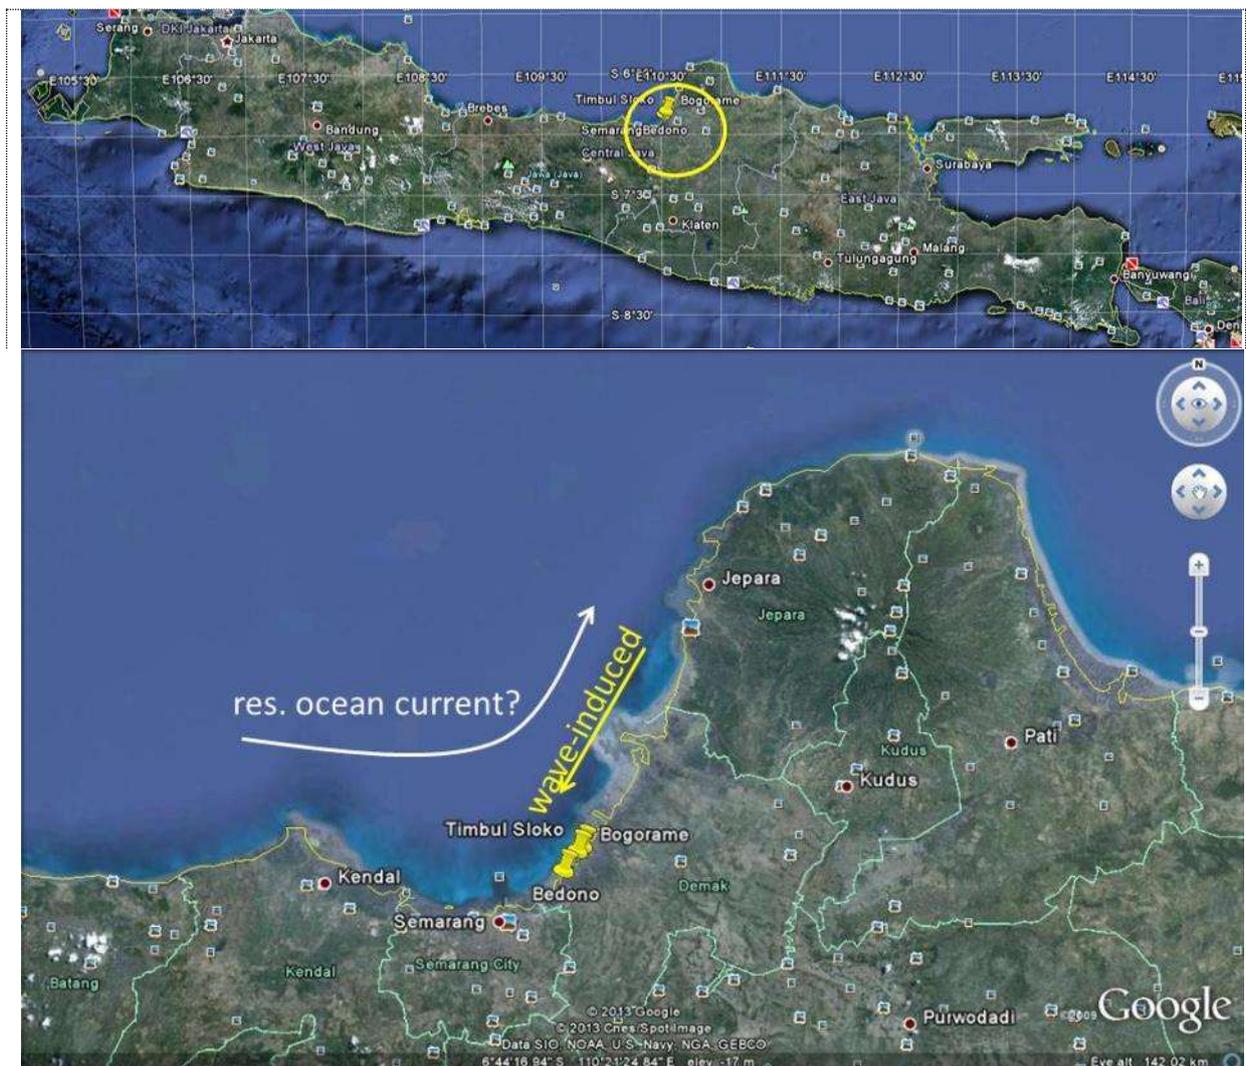
Figure 4: Java with Demak coast indicated by yellow circle (upper panel) and close-up of Demak district and coastline (lower panel), including indications of residual sediment transport.

overall high scores against our selection criteria and because of the opportunity to reach scale through the MMAF Resilient Village if the approach proves to be successful. See Figure 4 for the exact location.

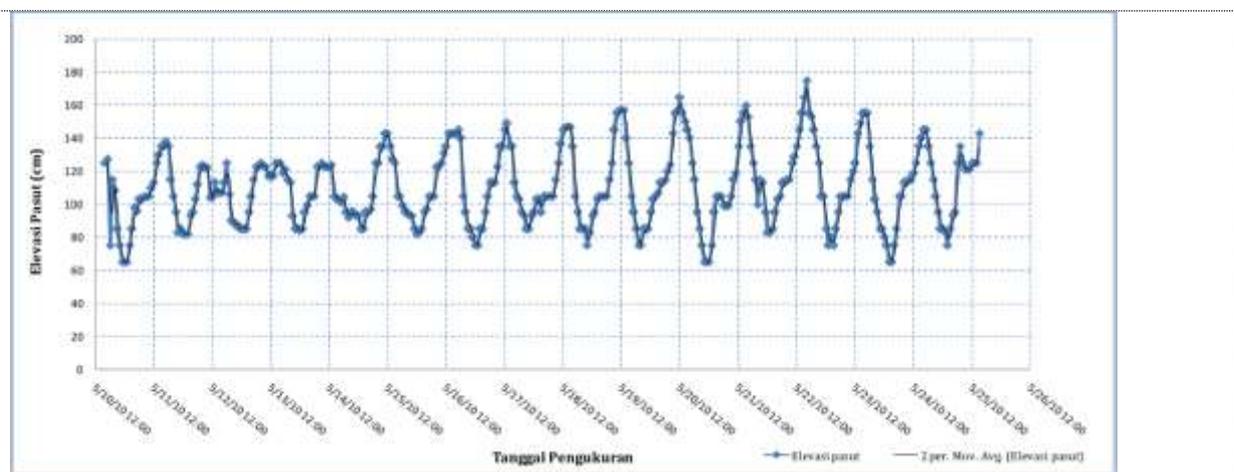
Figure 5 Time series of tidal elevation near Demak coast (after MMAF 2012).

The tide near the Demak coastline depicts a pronounced diurnal signal, with a small semi-diurnal component (Figure 5). Neap-tide tidal range amounts to about 40 cm, whereas spring-tide tidal range amounts to about 60 cm, but can be a bit larger when the semi-diurnal components synchronize with the diurnal components<sup>15</sup>. Currents in Sayung coastal waters vary, with maximal velocities of around 15 cm/s<sup>16/17</sup>. However, it is not known where these measurements were carried out. The majority of the measured currents appear to be directed in between East and South-East, which is more or less perpendicular to the Demak coastline.

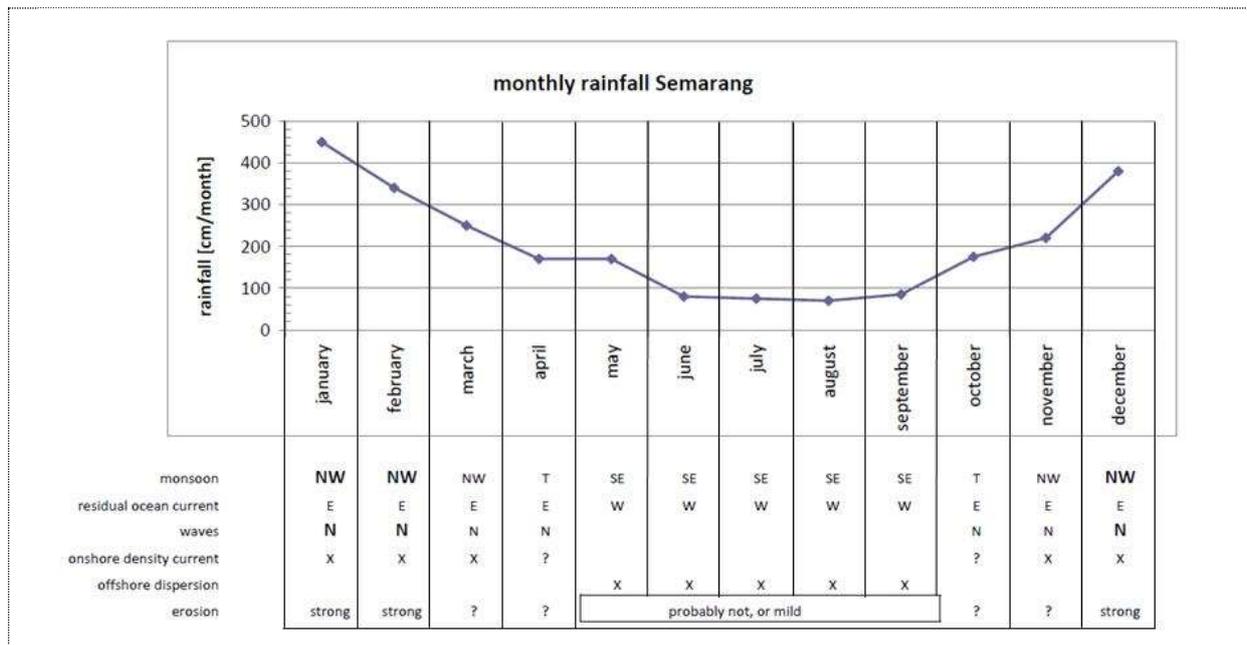
Fig. 5: Rainfall distribution in Semarang (BayongTjasyono et al., 2008) and summary of conditions relevant for the fine sediment dynamics along Demak coast (bold = energetic/dynamic conditions)

Rainfall distribution in Semarang<sup>20</sup>(Figure 5) can serve as a proxy for the distribution of the fresh water flow rate from the various rivers discharging into Demak coastal waters. The wind direction should have a profound effect on the dispersion of fresh water in the coastal waters. The wet season in Java is from about November through April, with December, January and February as the wettest months. During the NW-monsoon riverine fresh water plumes are pushed against the coastline, diverting to the East, following wind direction and residual currents. The fresh water distribution then induces a gravitational circulation along large parts of the coast, which keeps fine sediments close to that coast. On the other hand, during the SE-monsoon, which is the dry season (driest months June through August), fresh water is blown into the ocean (Java Sea) and the effects of gravitational circulations are much more localized. Then, no large-scale mechanism works to keep the fine sediments close to the coast.

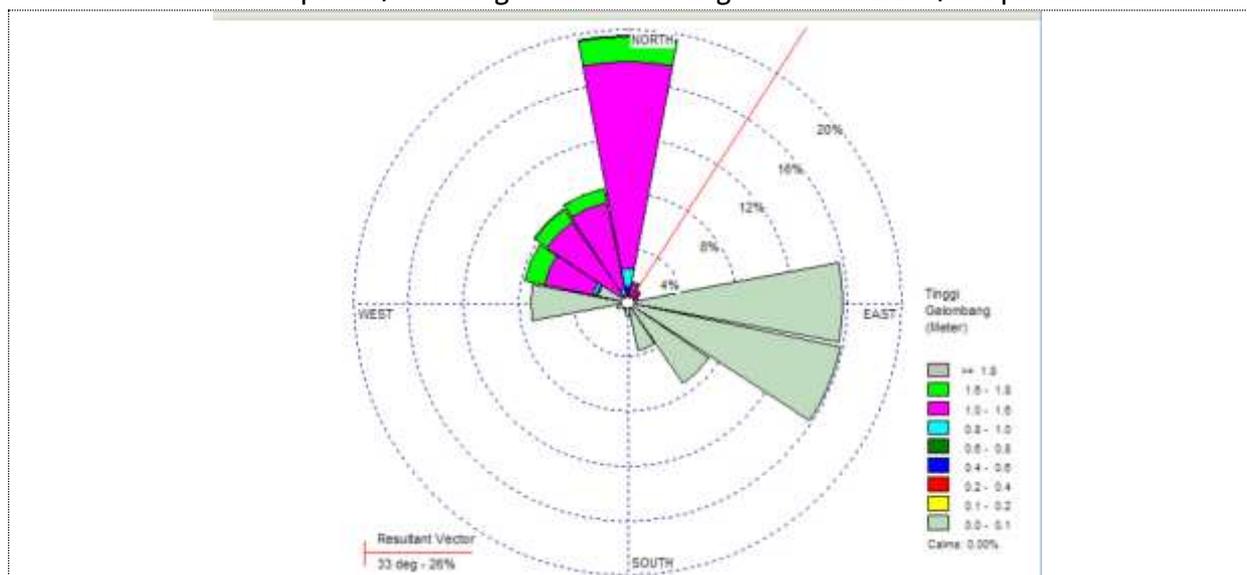
Figure6 Wave rose along Demak coastline for the years 2003-2009 (after MMAF, 2012).

Figure6 presents the wave rose as measured in Demak coastal waters<sup>21</sup>, about 3.5 km off the original, undisturbed coastline (at the precise location of 110° 26' 41.6" E and 6° 54' 36.9" S). Wave heights up to 1.8 m are reported, whereas the maximum significant wave height amounts to about 1.5 m, with a period of about 5.5 s. An evaluation of 14 years of wave data of the measuring station near Semarang showed that mean wave height in this area equals 0.46 m. and maximum wave height lies between 2.6 -3.0 m<sup>22</sup>. However, the latter is offshore. Note that all relevant waves come from between North and WNW, with the majority of the waves from the North. Of course, the north coast of Java is very much exposed to these waves. Note that for the year 2009 much larger maximum waves are reported, with a significant wave height of about 2.2 m, at a period of over 8 s.

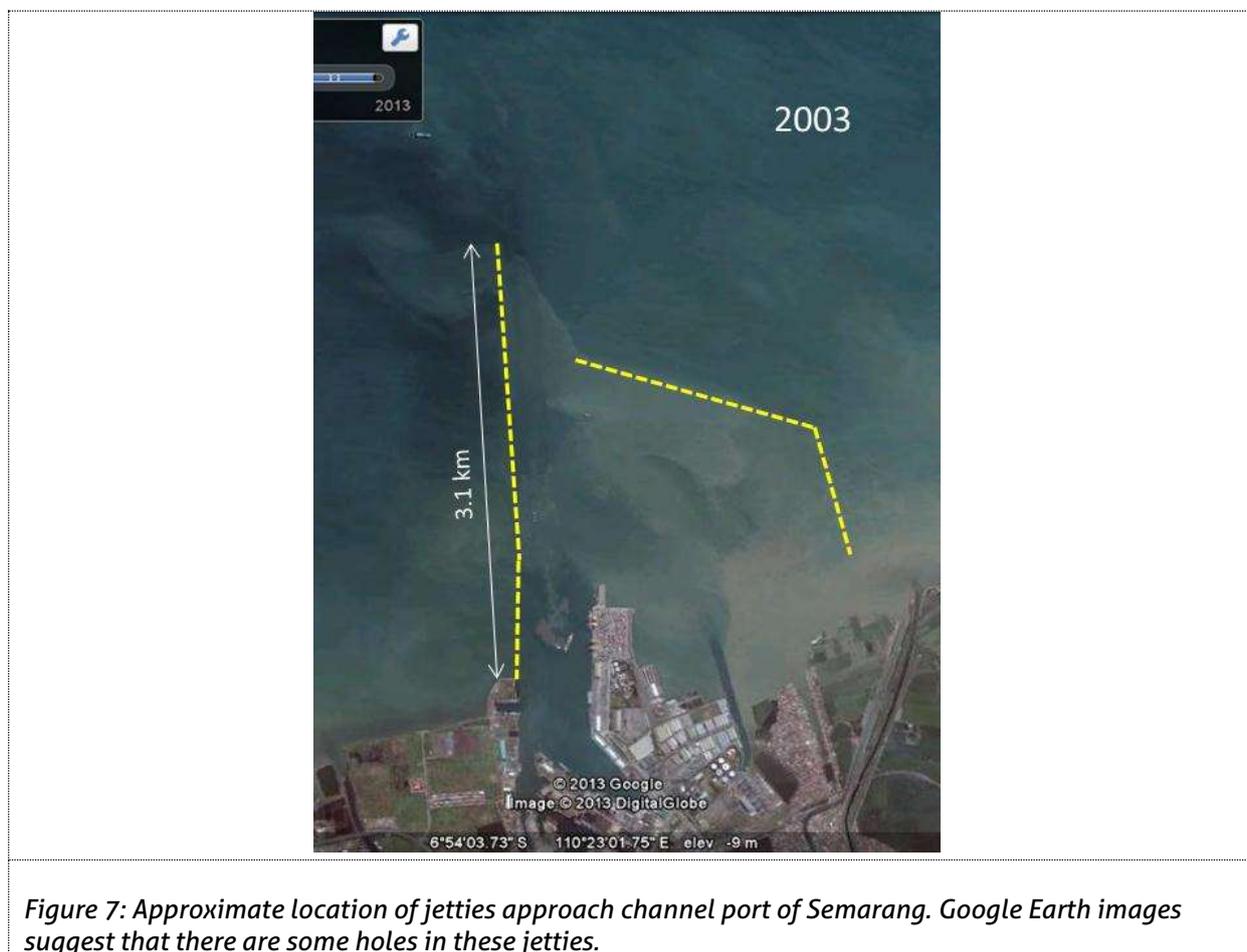
Figure 7: Approximate location of jetties approach channel port of Semarang. Google Earth images suggest that there are some holes in these jetties.

Coastal erosion can be caused by multiple factors amongst which the factors as described in section 4.1. However, direct anthropogenic influences in the environment, such as building of harbour piers and jetties and of coastal defences may have profound impact on coastal erosion and deposition patterns as well. For example, the jetties, protecting the port of Semarang, penetrate some 3 km into the sea (Figure 7), affecting eastward oriented residual fine sediment transports.

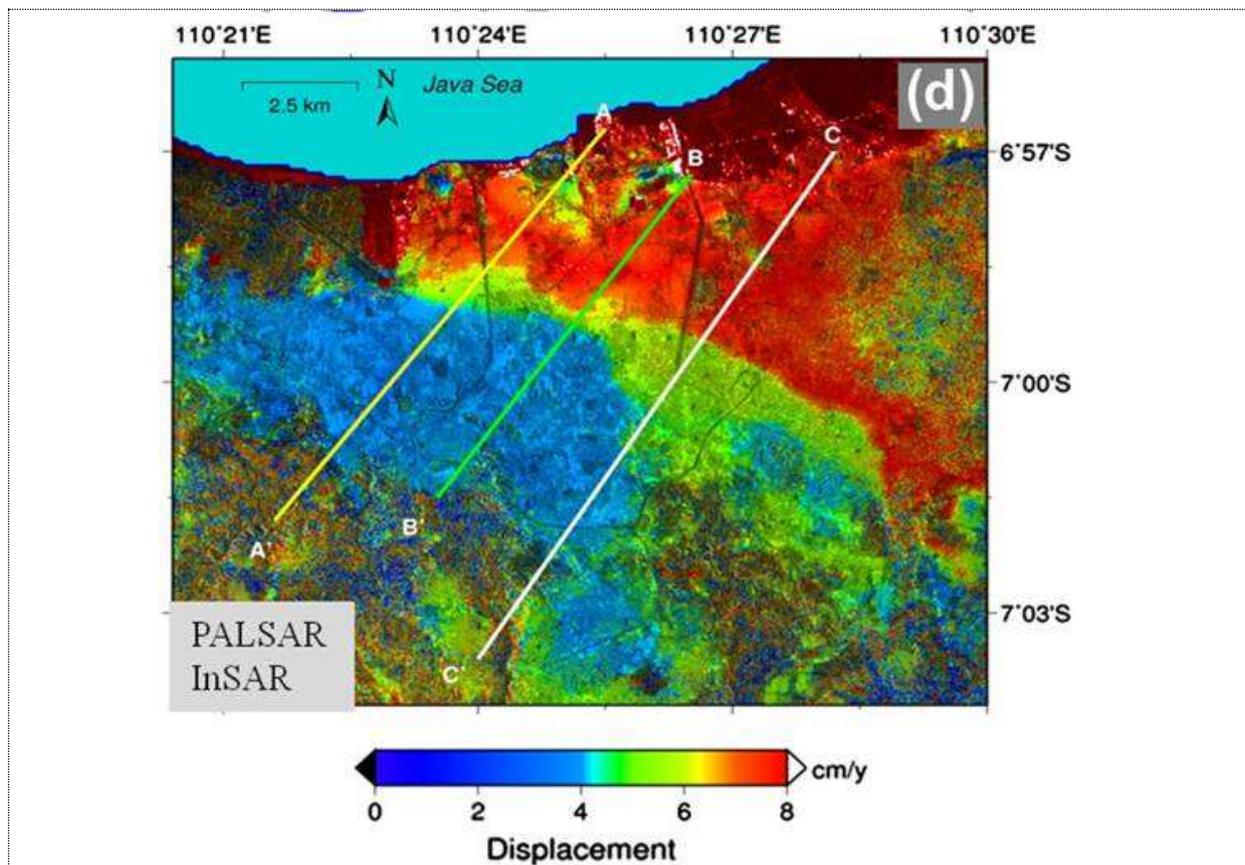
Figure 8 Yearly subsidence in cm/yr based on measurements of Lubis et al. (2011) between Jan 2007 and Jan 2009.<sup>24</sup>

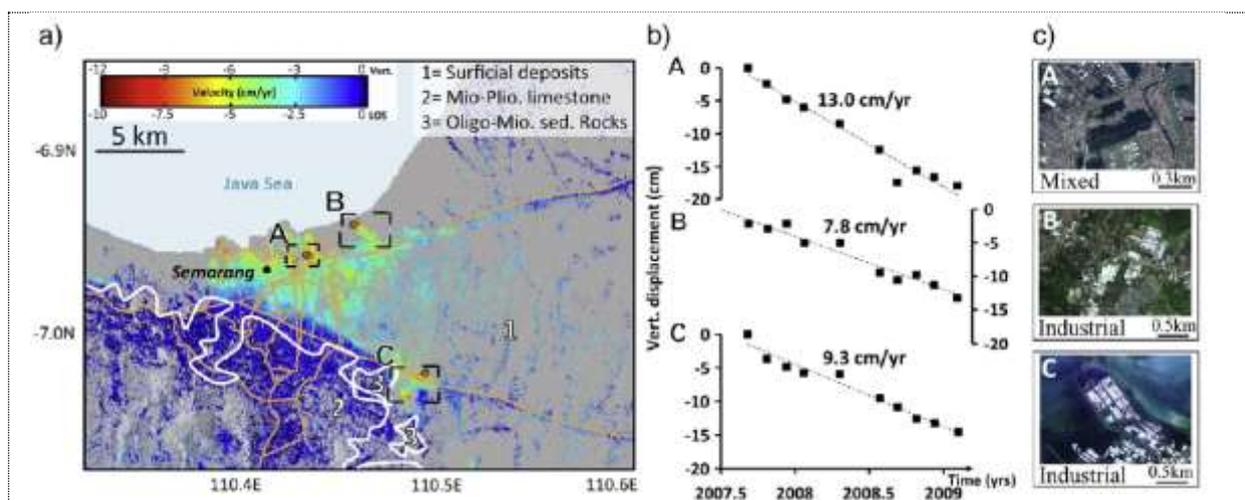
Figure 9 Subsidence observed near Semarang. a) Average 2007–2009 subsidence rate map. Roads are shown in light brown and main towns are labelled for reference. The contours of the geologic units are shown by white lines and referred to using white numbers. The black boxes show the locations of the Google Earth optical images displayed in c) corresponding to areas experiencing rapid subsidence. Black circles within the boxes show the location of the pixels whose time-series are showed in b). b) Vertical displacement time-series and corresponding linear rates of subsidence. c) Google Earth optical images showing the type of land use in rapidly subsiding areas<sup>25</sup>.

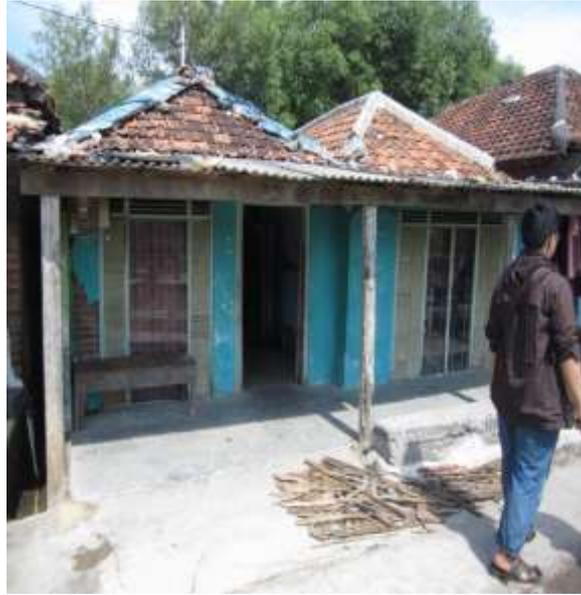
*Figure10 Houses close to the coastline in the Wonorejo part of Timbulsloko. The height of the house points at the presence of subsidence (photo B.K. van Wesenbeeck).*

Subsidence rates for the Timbulloko area are not known. However, there are some signs of subsidence (see Figure 10). Further, the village seems to possess a deep ground water well that might have been used for irrigation purposes as well. More information on this aspect should be collected.

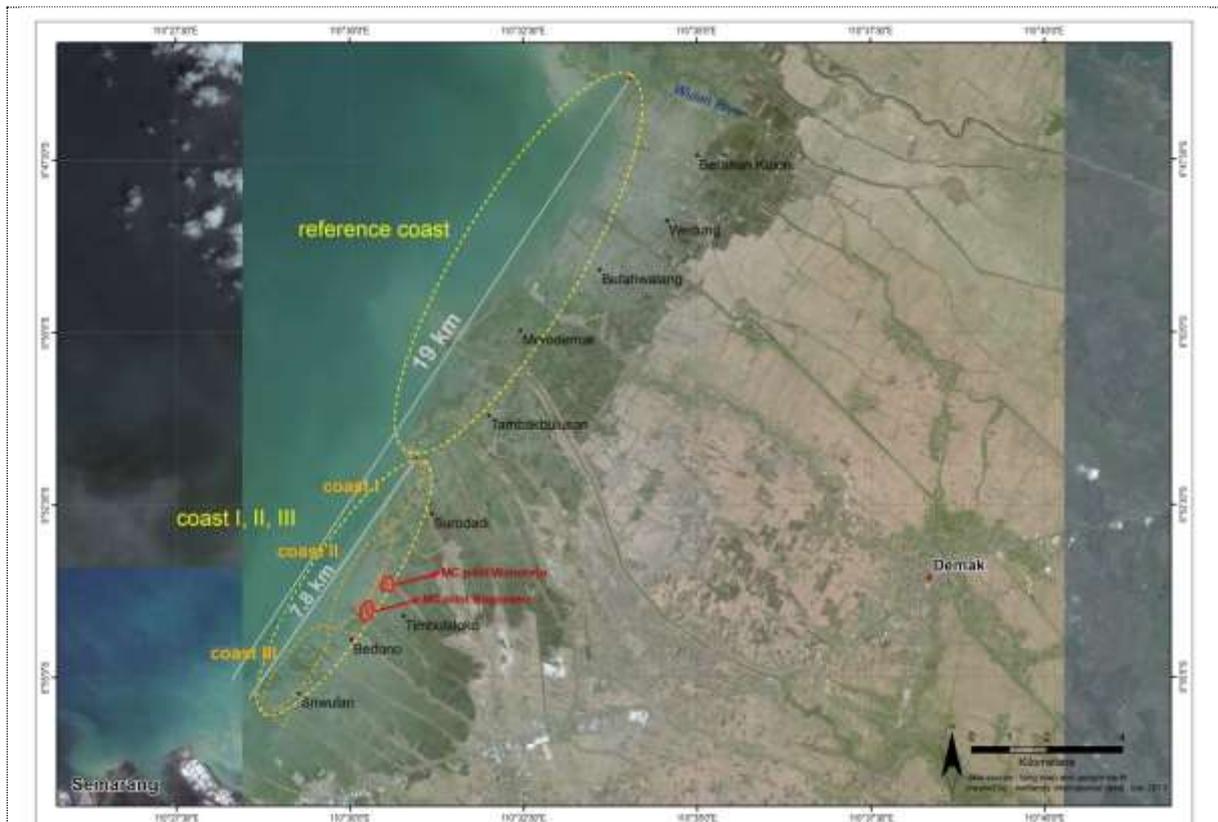
*Figure 11 Demak coastline – coastal stretch of in total 19 km for large-scale Hybrid Engineering. The Southern part of Demak coast of around 7.8 km can be sub-divided into three sub-sections, characterized by different erosion patterns. The location of the small-scale Hybrid Engineering-pilot within the framework of Mangrove Capital is indicated (2013 Google Earth satellite image).*

In this section we explore the evolution of a coastal stretch of approximately 19 km in Demak district, from just east of Semarang to Wulan River (Sungai Wulan), see Figure 11. We use both anecdotal information describing the last century and an analysis of Google Earth images of the last decade, see the original series of images in Appendix II. The 19 km Demak coast consists of a northern part with a still fairly stable coastline (referred to in this report as the 'reference coast'), while the coasts erodes progressively when moving south in the direction of Semarang (referred to as 'coast I, II, III'). In the coastal area of Demak houses are mainly built on river banks. This explains the extreme ribbon-building pattern in Demak district.

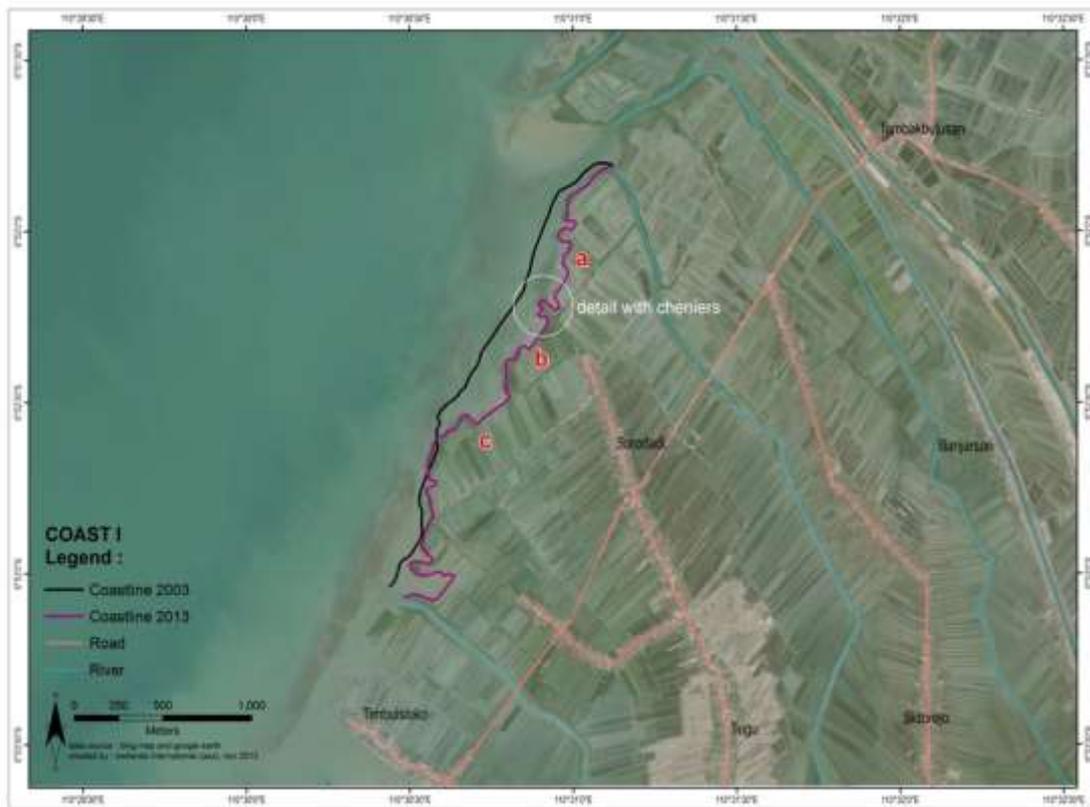
Figure 12 Demak Coast I with approximate coastlines 2003 and 2013 (Google Earth images); see Figure 13 for details.

Figure 12 depicts the coastline of Demak coast I in 2003 and 2013, suggesting an erosion of about 100 – 300 m. The coastline seems to have retreated fairly regularly, except for three “cavities” (a, b, c), where erosion follows the lay-out of fish/shrimp ponds. Further zooming in with Google Earth suggests that most of this coastline is still fairly well protected by a series of cheniers (e.g. thin and narrow lenses of sand on top of the muddy seabed), indicated in Figure13 showing details of coast I.

1. Create sheltered areas in the "cavities" a, b, and c (Figure 12) with permeable structures, similar to those presented in Chapter 4.3.
2. Build out the coast parallel to the 2013 coastline with permeable structures spaced about 100 m from each other, following the lay-out of former bunds for the foundation of the structures. We propose the following:
  - Application of different materials for the permeable structures in dialogue with local parties, including Boskalis'geohooks for one particular stretch;
  - Enhancing the suspended fine sediment concentration in the foreshore by mechanical means (mechanical agitation of the seabed).

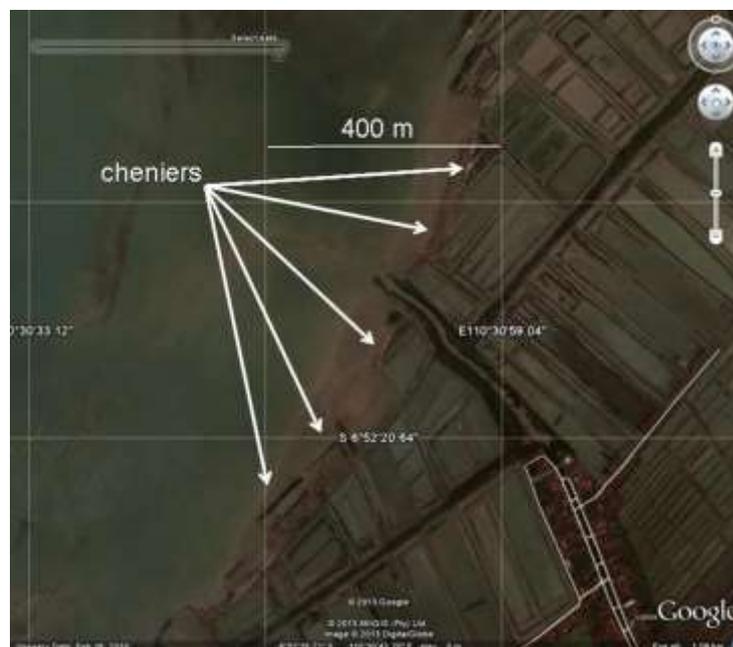
Figure 13: Details of coast I, showing some cheniers along the coast.

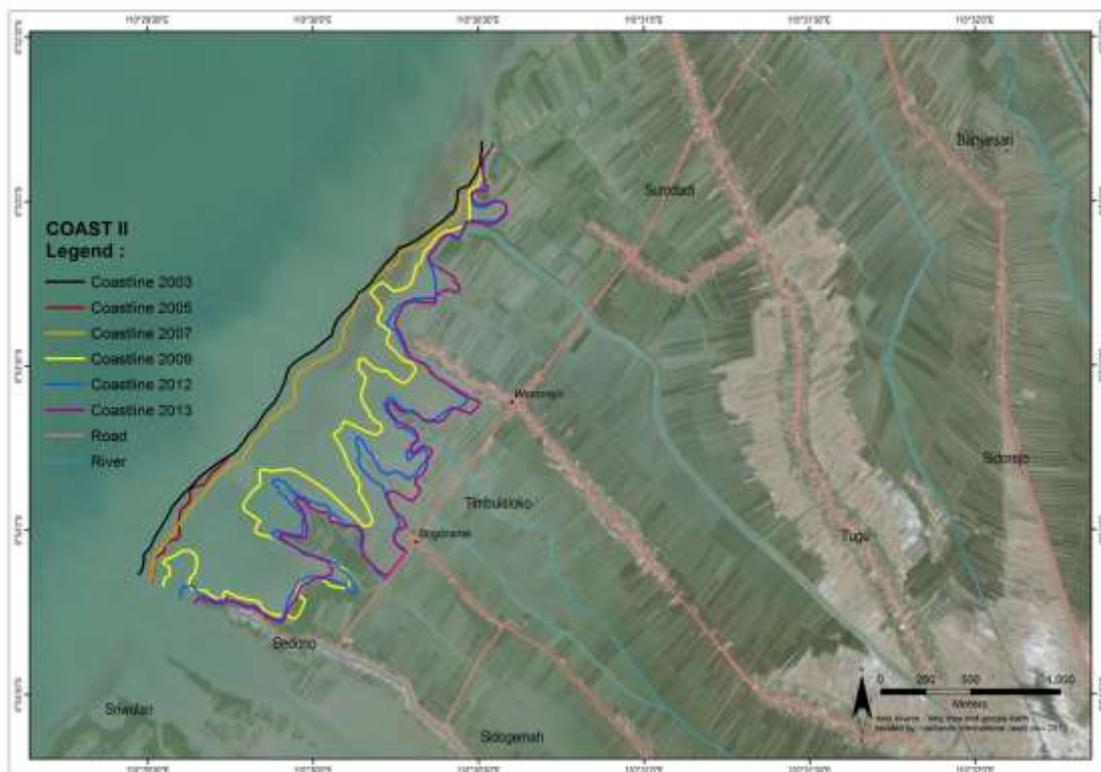
Figure 14 Demak Coast II, showing progressive coastal retreat from 2003 to 2013. Google Earth Images.

Figure 14 presents Google images of Demak coast, coast II in 2003, 2005, 2007, 2009, 2012 and 2013. We have indicated the coastline in 2003 in all figures. Up to 2007, the coastline is fairly stable, with some erosion. In between 2007 and 2009, the coastline has retreated largely, by many hundreds of meters, at locations up to 1 km. This big response might be attributed to the larger waves in 2009 (e.g. Section 4.2). However, there may be other causes:

Figure 14 shows that erosion is difficult to control from 2009 onwards, and land is continuously lost. The road connecting Wonorejo and Bogorame sub village now seem to control further erosion of the hinterland. However, signs of deterioration of the road are already visible. In certain parts the road is almost continuously submerged (except for very low tides) and in other parts erosion of the road is clearly visible. Safeguarding this road seems a vital step in stopping erosion from proceeding further inland. The road can be protected by placing permeable groin structures in front of the road. However, the main construction and the base of the road should be improved simultaneously.

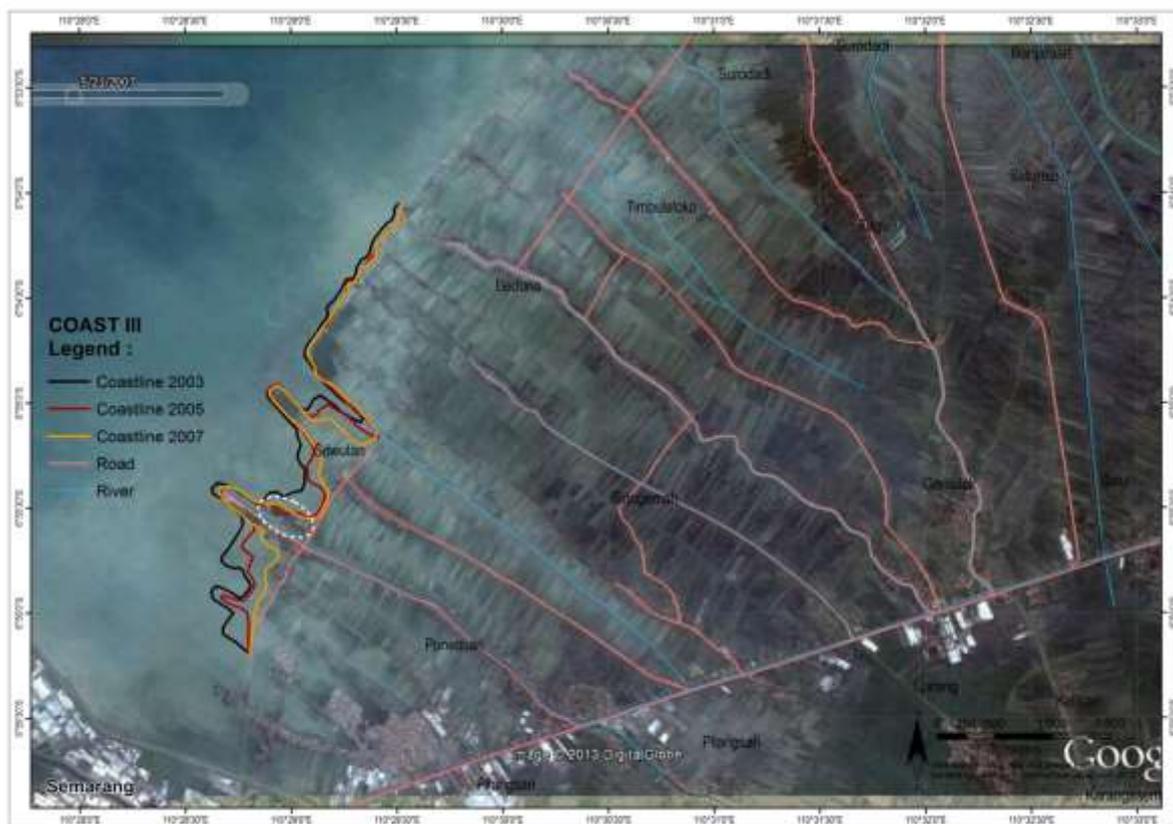
Figure 15 Demak coast III, showing the approximate coastline in 2003, 2005 and 2007 (Google Earth Images).

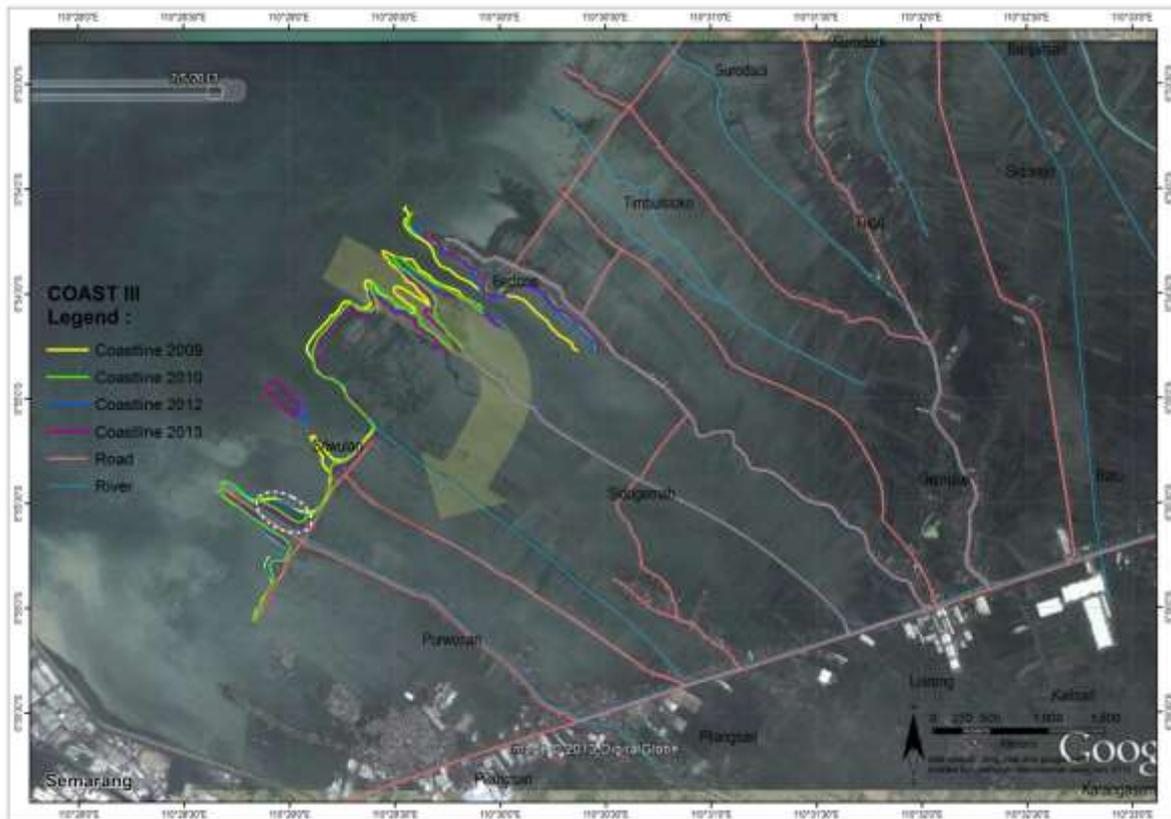
Figure 16 Demak coast III, approximate coastline 2009, 2010, 2012, 2013 (Google Earth Images). Yellow arrow indicating erosion 'through the back door'.

Between 2007 and 2009 this part of the coastline seems to collapse rapidly. As the road seems still to be intact, flooding and eroding seem to have occurred through “the back door”, as indicated by the yellow arrow in Figure 16. In the years following 2009, the fish/shrimp ponds behind the road degenerate further, owing to negligence of the remaining bunds, further wind-induced erosion, and/or ongoing subsidence.

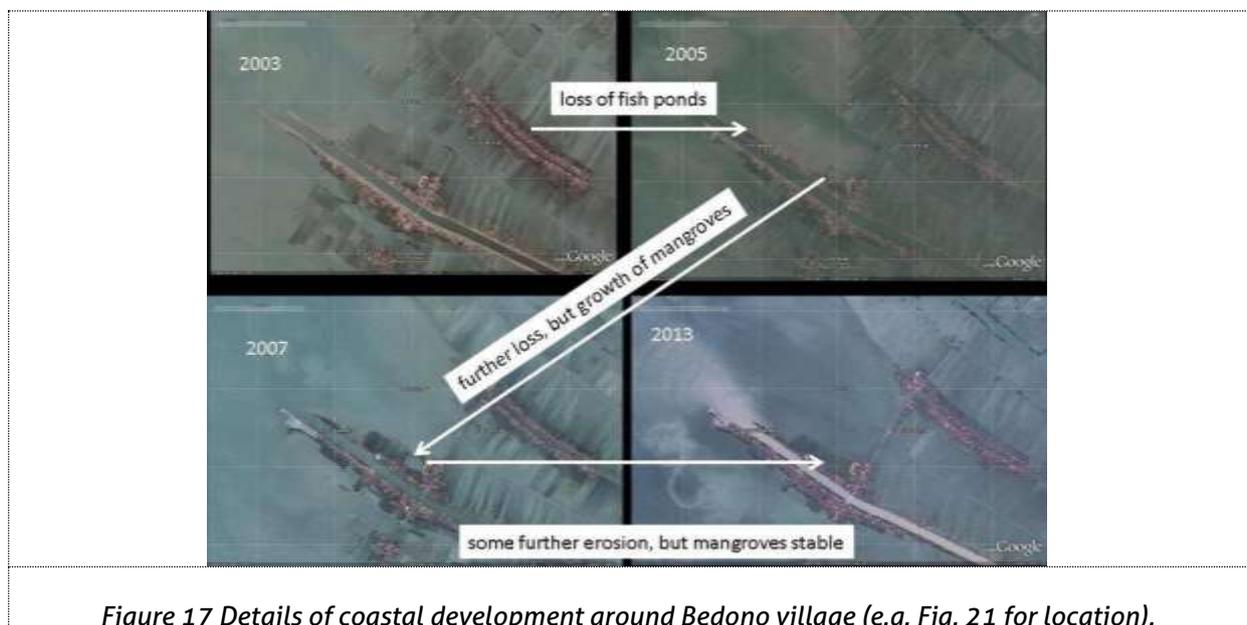
Figure 17 Details of coastal development around Bedono village (e.g. Fig. 21 for location).

Figure 17 zooms in on the evolution around Bedono village. The important observation here is that after the loss of fish ponds, mangroves seem to recover where conditions are favourable, i.e. in sheltered areas. This recovery has been observed at other locations around Demak district as well, in particular around Bogorame. In sheltered and rapidly accreting areas (often in between still present bund of eroding fish ponds that are filled with sediment) natural recovery of *Avicennia marina* has been observed (pers. obs.).

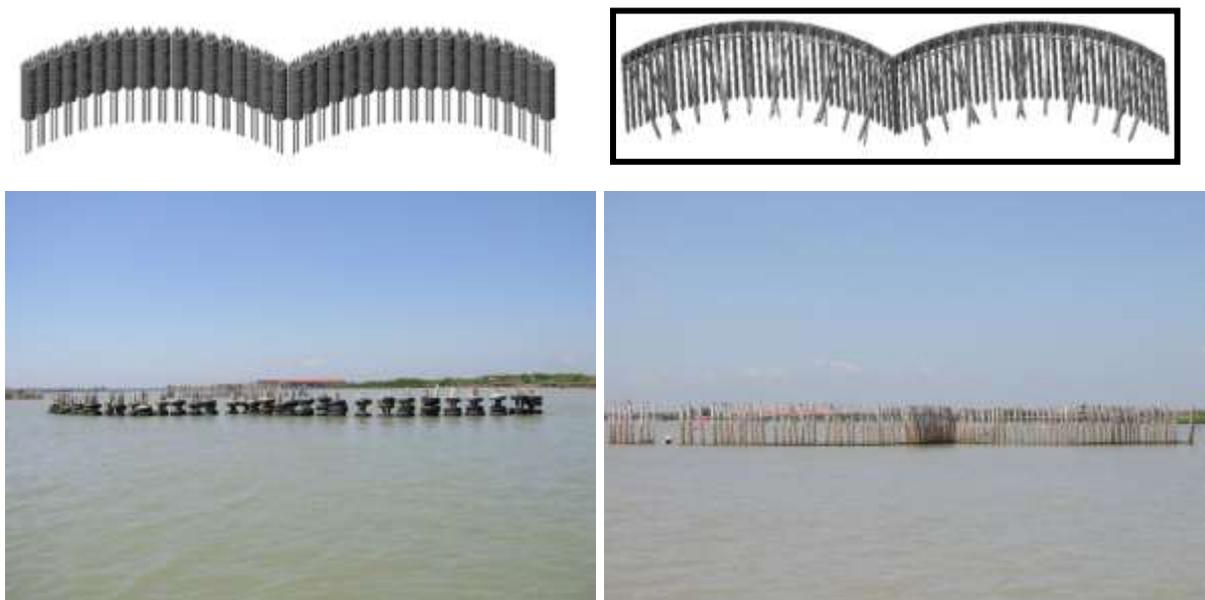
Figure 18 Illustrations (top) and photos (bottom) of wave breakers (APO) along Demak coast.

Further, MMAF (DKP) and the Ministry of Environment are also involved in several projects where construction of breakwaters (called APO) and seawalls takes place (Figure 18). Many of these structures are permeable. However, sometimes these structures were somewhat too permeable, so that they do not dissipate the waves enough. In other cases, concrete structures are placed. These structures reflect the waves so that eroding forces increase and they prevent sediment input to the tidal flat (see Chapter 4.2). Although these structures may provide some relief in the immediate term, they will eventually exacerbate the problem.

Concrete seawalls show signs of deterioration sometimes already within a year of their construction. This is the result of the enhanced erosion rates at the foot of such structures, as explained above.

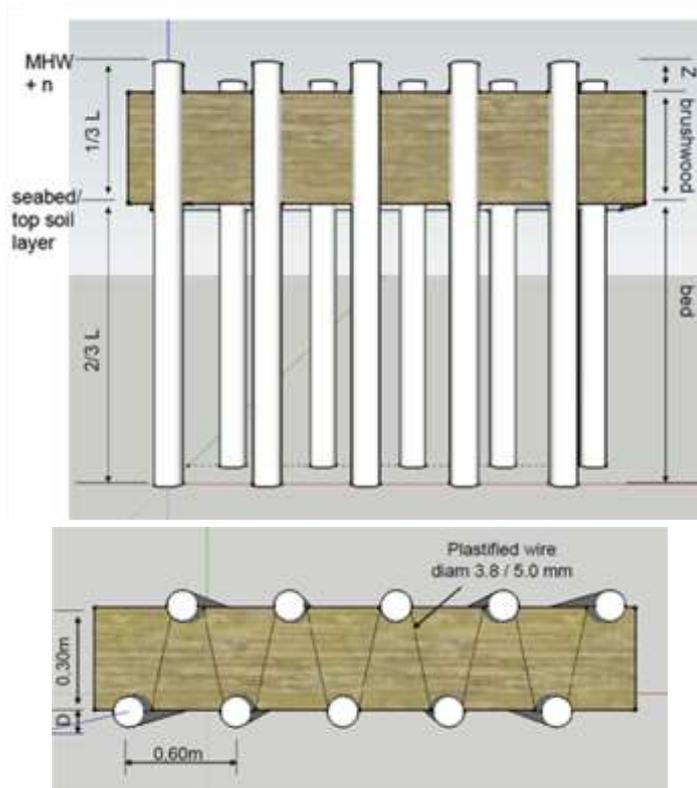
Figure 19 Permeable structure design. MHW = Mean High Water. Top: view from the side, bottom: view from above.

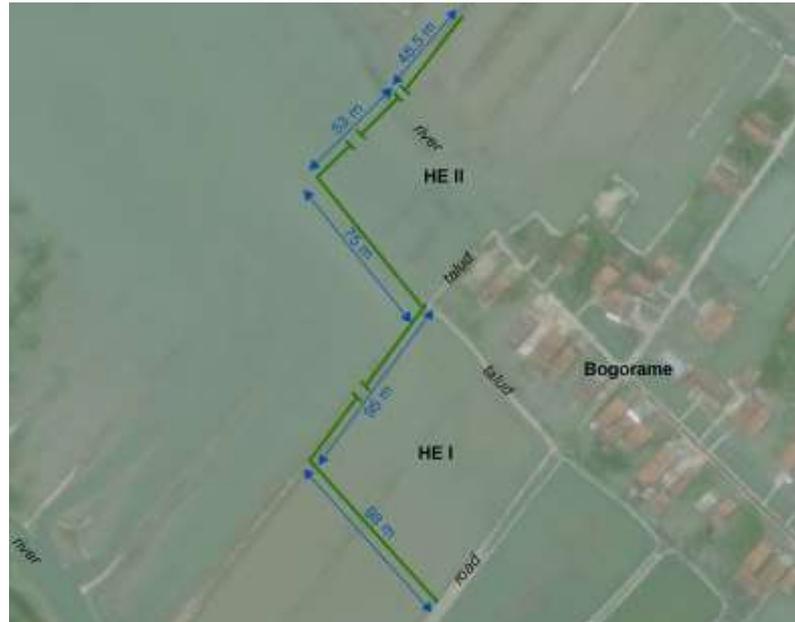
Figure 21 Design of two permeable structure grids at the coastline of Bogorame.

We recently started prototype testing this approach together with MMAF, Diponegoro University and local NGO Kesematand we include the applied layout of permeable structures here as an example. Coastal erosion in sub village Bogorame has already proceeded until the road and also the village itself is severely threatened. No breakwaters were yet constructed in front of the coast which is an advantage

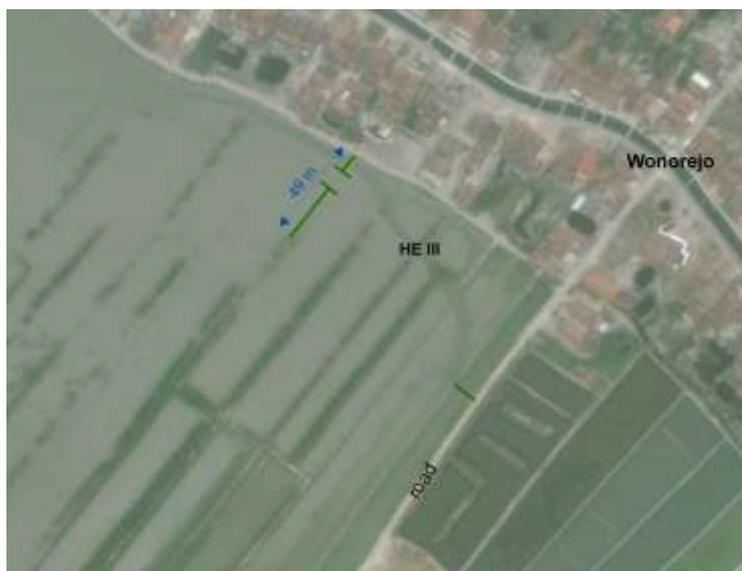
Figure 22. Design of permeable structure near Wonorejo.

In sub village Wonorejo apply a different layout since the area is more fragmented. The area West of Wonorejo is already heavily influenced by planting of Rhizophora on old bunds of shrimp ponds. Certain plantings of Rhizophora are growing rapidly and are forming lines in the landscape. In between these lines, old fish ponds have filled in with sediment, especially those ponds bordering the river. Note that this may also be caused by the fact that these ponds are protected and not fully exposed to most heavy wind and wave directions. In the areas that filled in with sediment, natural Avicennia recruitment can be observed. As fetch in this area is not so large, while erosion in the area near the seawall of Wonorejo is large, we chose to enhance sedimentation in a larger area at once by constructing a single large permeable structure on the front. This permeable structure is meant to reduce wave impact from the front edge and allow sediment to settle in the area behind. The permeable structure borders the present seawall of Wonorejo in
