# A sustainable solution for massive coastal erosion in Central Java

~ Towards Regional Scale Application of Hybrid Engineering ~  
Discussion paper

February 2014

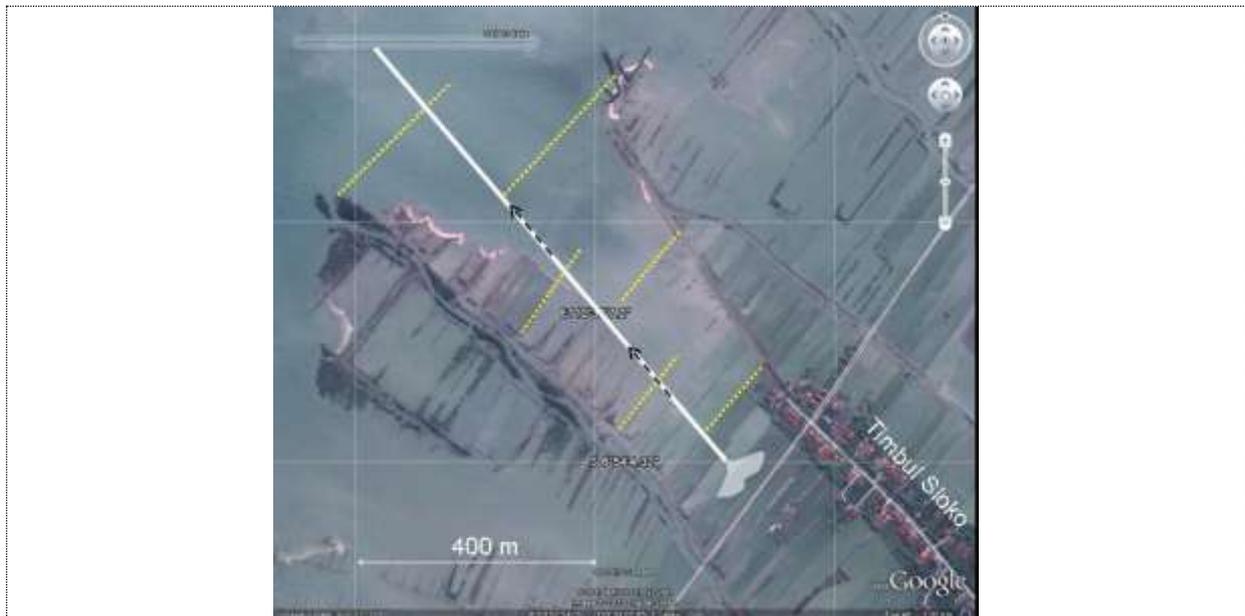
Figure23: Sketch of mud nourishment around TimbulSloko with six semi-permeable structures (yellow dotted lines) and floating pipeline supplying fluid mud (white line) – over time, the pipeline should be withdrawn in seaward direction.

5. Large-scale mud nourishment, guided by alternating permeable structures, creating semi-enclosed basins. We anticipate that this semi-enclosed lay-out will help to create the proper slopes of the nourishments. A lay-out for the area west of TimbulSlokois sketched in Figure23 Mud volumes to be nourished should follow from numerical modelling.

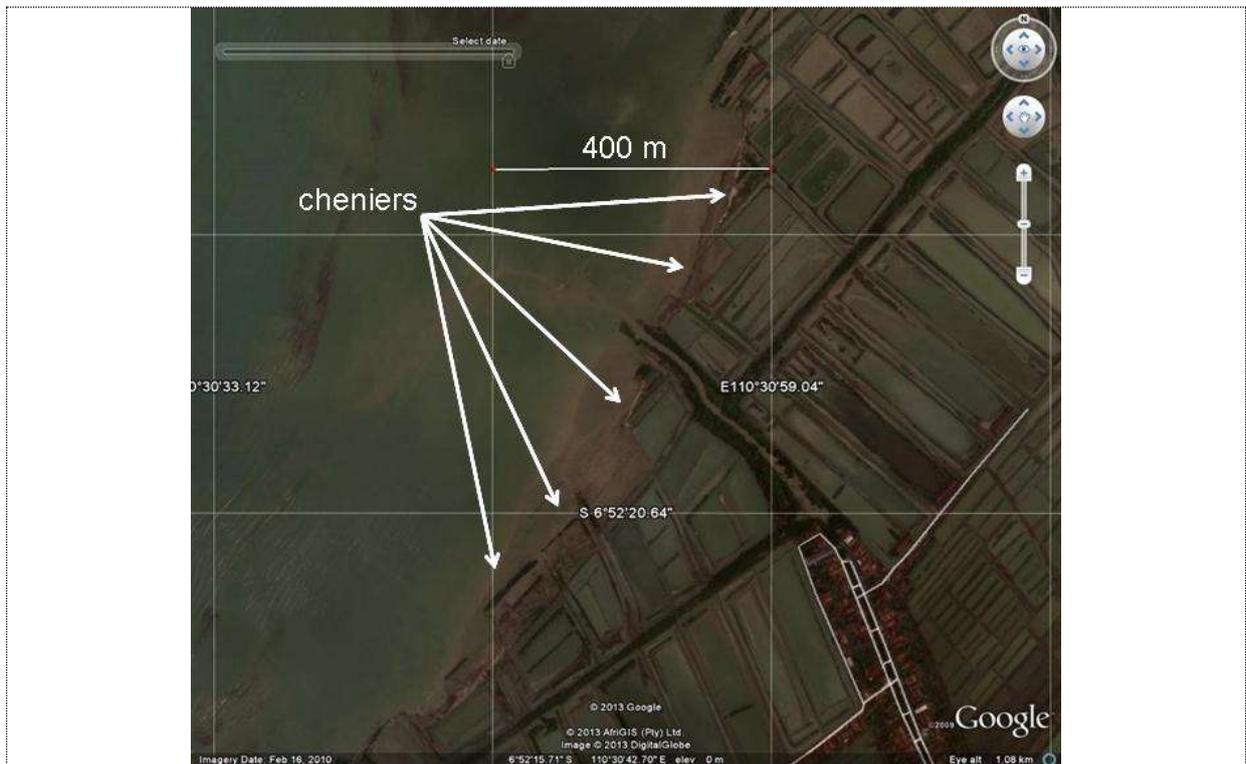
*Details of coast I, showing some cheniers along the coast.*
